Manhole Inspection Summary

Manhole # S51GG_007MH

Insp Date: **6/9/08 8:05 AM**

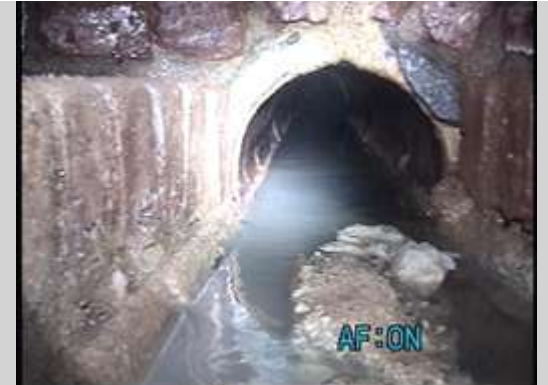
12 O'Clock Outflow

8 in. Circular Gravity Sewer
Pipe Out @ 12 O'Clock

Pipe Height: **8.4** (in.) Rod and Bar (Angled)
Pipe Material: **Clay** ☐ Pipe Lined
Invert Depth: **19.90** (ft.) Flow Characteristics: **Fast**
Deposits: ☒ None ☐ Mud ☐ Sludge ☐ Debris ☐ Grease
Silt Depth: (in.) Deposits Extent:
Infiltration: **None** Pipe Seal Cond: **Sound**

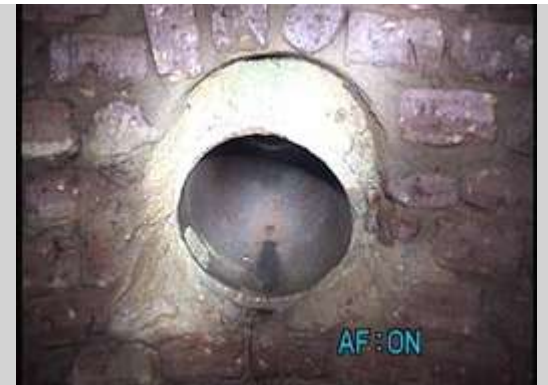
3 O'Clock Inflow

8 in. Circular Gravity Sewer
Pipe In @ 3 O'Clock

Pipe Height: **8.4** (in.) Rod and Bar (Angled)
Pipe Material: **Clay** ☐ Pipe Lined
Invert Depth: **12.55** (ft.) Flow Characteristics: **Fast**
Deposits: ☒ None ☐ Mud ☐ Sludge ☐ Debris ☐ Grease
Silt Depth: (in.) Deposits Extent:
Infiltration: **None** Pipe Seal Cond: **Sound**

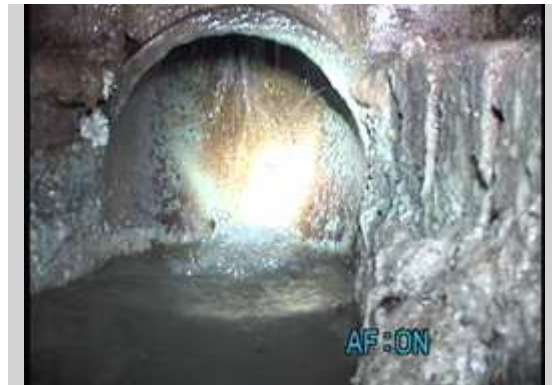
Drop In @ 3 O'Clock

Drop: **Outside** Rod and Bar
Angled: **Yes** Reading: **18.85** (ft.)
Inv Depth: **19.85** (ft.)

Drop Condition: **Open**

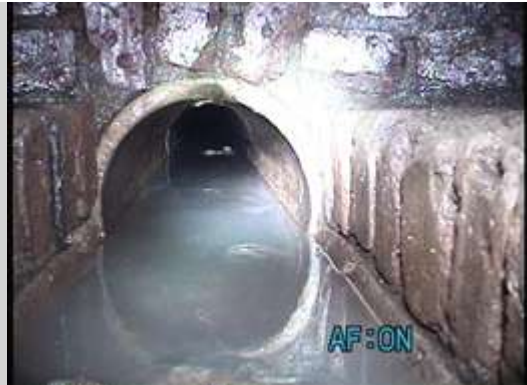
6 O'Clock Inflow

8 in. Circular Gravity Sewer

Pipe In @ 6 O'Clock

Pipe Height: **8.4** (in.) Rod and Bar (Angled)

Infiltration: **None** Pipe Seal Cond: **Sound**
